# CARDONE™ ProTech®

## Optimizing GM's Opti-Spark Distributors

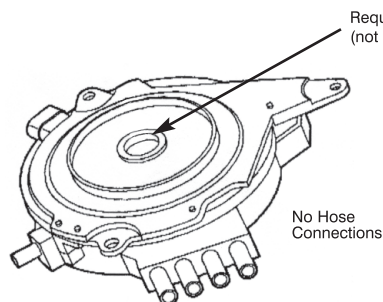
Design 1

(30-1832)

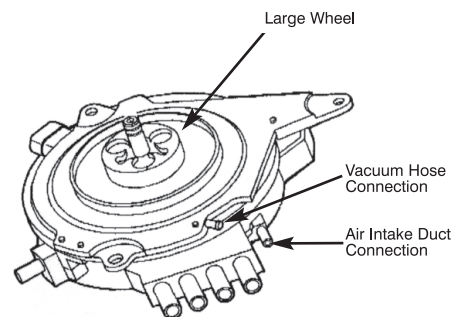
Design 2

(30-1803 & 1833)

- Verify that units equipped with the Positive Vent System (see design 2 below) do not have lines that are clogged or kinked.
- Check the vacuum source and lines at the intake manifold under the throttle plates for kinks or restrictions.
- Clean debris from housing vents and around distributor housing.
- Use anti-conductive grease when installing connector to prevent corrosion.
- Inspect coolant hoses around distributor for leaks.
- Check connectors for corrosion. Repair or replace vehicle connector as needed.
