CDI P/N 123-9898-P

NOTE: This install sheet covers the 123-9898-P Electronic Shift Assist (ESA) module for boats equipped with a distributor using mechanical breaker points or an aftermarket electronic points replacement kit. If your boat has another type of distributor please call CDI for a cross reference to the correct part for your application.

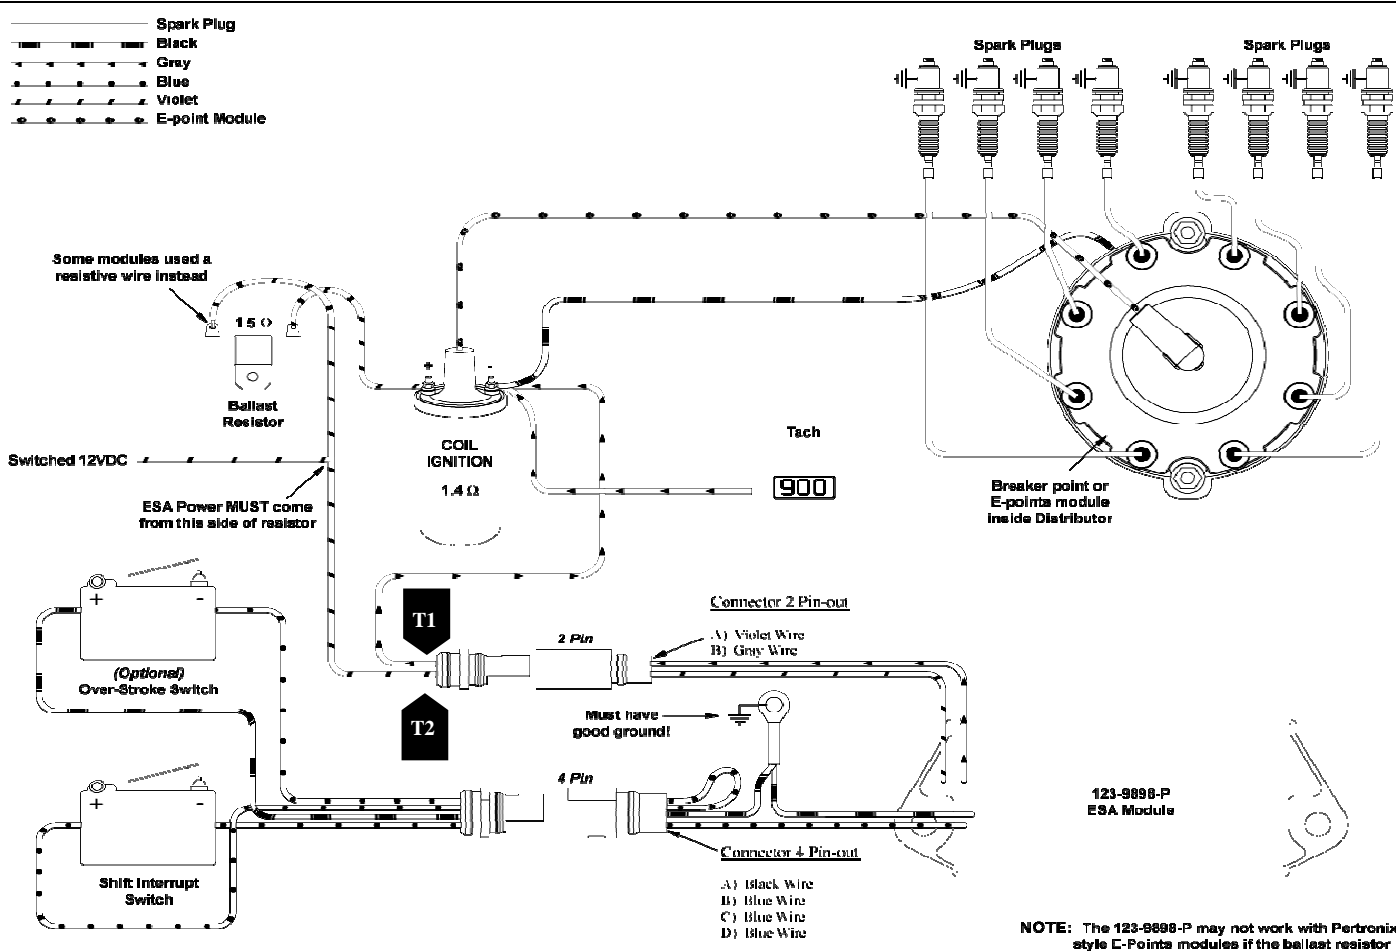
Ballast Resistor Required
3 Ohms – Step 2 reading =
(See Table for Selection)

Step 1- Disconnect all wires from the coil and measure its resistance.

Step 2- Measure circuit resistance between Gray and Violet wire

Step 3- Calculate how much ballast resistance to add.

3. Verify correct Ignition circuit resistance. (See Page 2)
 - A) Measure resistance of the coil (Step 1). Normal coil resistance should be 1.5Ω, if less resistance is found a higher resistance ballast resistor may be needed.

This usually only occurs with performance coils and modified ballast resistance. The higher the current in the ESA the more likely failure will occur. Typical ESA circuit current should not exceed 4-5 amps. With an aftermarket coil, ESA circuit current can exceed 10 amps. A typical stock set up uses a 1.5Ω coil and a 1.5Ω ballast resistor (3Ω total).
